# Manhole Inspection Summary

Manhole # S21WW1011MH

Insp Date: **11/29/06 3:22 PM**

**Location** Address: **BOUTON GREEN CT**

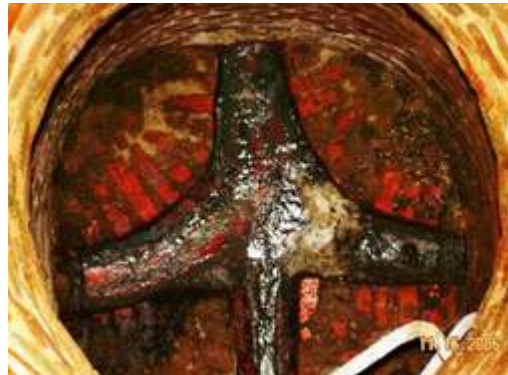
Top View

Evidence of surcharge - Bench debris.  
Channel debris.

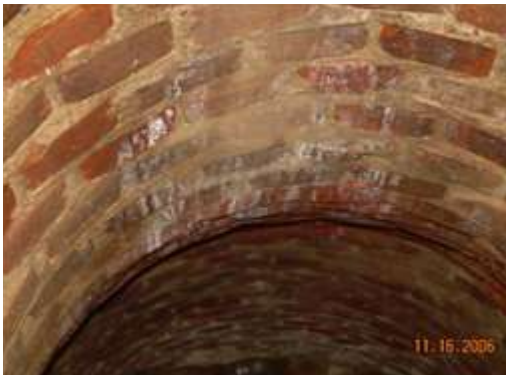
Defect

**Chimney / Frame Adjustment** ☒ Exists Material: **Brick** ☐ Parged Height: **24** (in.)

Infiltration: ☐ None ☒ **Joint** ☐ Cracks ☒ **Mortar** ☐ Roots ☐ Wall

Infiltration: ☐ None ☐ Joint ☐ Cracks ☒ **Mortar** ☐ Roots ☒ **Wall**

Adjustment and Barrel infiltration.

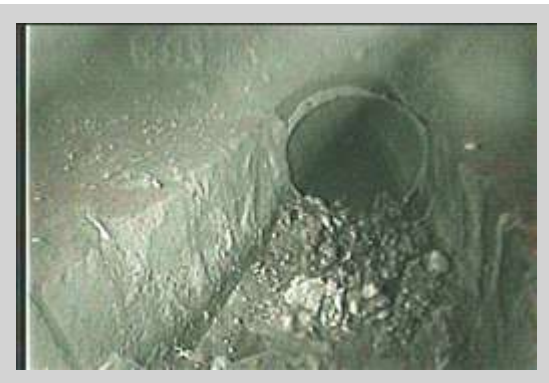
### 6 in. Circular Gravity Sewer Pipe In @ 3 O'Clock

Channel debris.

Silt Depth: **1** (in.) Deposits Extent: **Light**

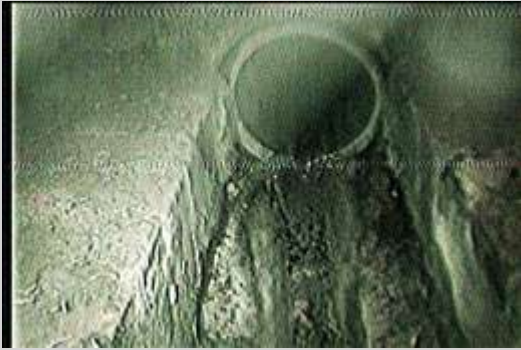
### 6 in. Circular Gravity Sewer

Condition: ☐ Sound ☐ Cracked ☐ Root Intrusion ☒ **Deteriorated** ☐ Leaks ☐ Debris

Channel deterioration.
